Manhole Inspection Summary

Manhole # S45EE_043MH

Insp Date: **2/17/10 3:04 PM**

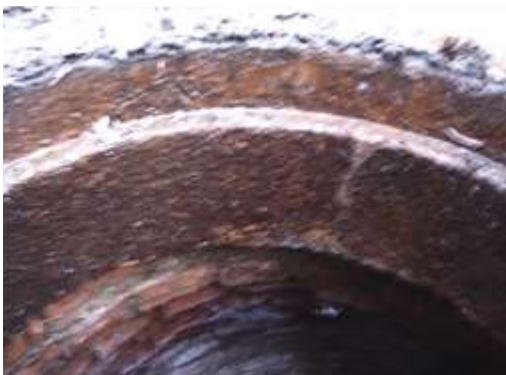
Defect 1

Frame Offset: **0** (in.) Condition: ☐ Sound ☐ Cracked ☒ **Leaks**

frame leaks

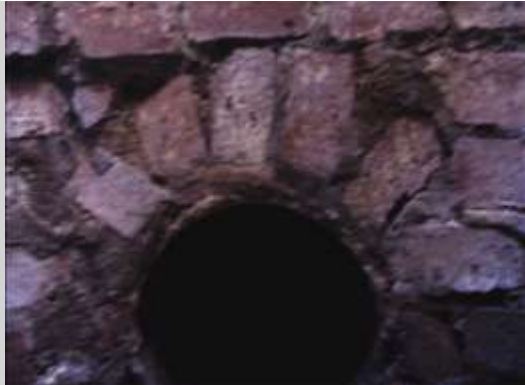
12 O'Clock Outflow

8 in. Circular Gravity Sewer
Pipe Out @ 12 O'Clock

Infiltration: **None** Pipe Seal Cond: **Sound**
